4. TITLE (and Subtitle) Phase I Inspection Report National Dam Safety Program Lake Como Dam Kent County, Delaware		5. TYPE OF REPORT & PERIOD COVERED FINAL

7. AUTHOR(s) JOHN J. WILLIAMS, P.E.		6. PERFORMING ORG. REPORT NUMBER
9. PERFORMING ORGANIZATION NAME AND ADDRESS O'Brien & Gere Engineers, Inc. Suite 1760 1617 J.F. Kennedy Blvd. Philadelphia, PA 19103		8. CONTRACT OR GRANT NUMBER(s) DACW61-80-D-0013 ✓

14. MONITORING AGENCY NAME & ADDRESS (if different from Controlling Office) National Dam Safety Program, Lake Como Dam (DE 00028), Delaware River Basin, Mill Creek, Kent County, Delaware. Phase I Inspection Report.		12. REPORT DATE Nov. 1980

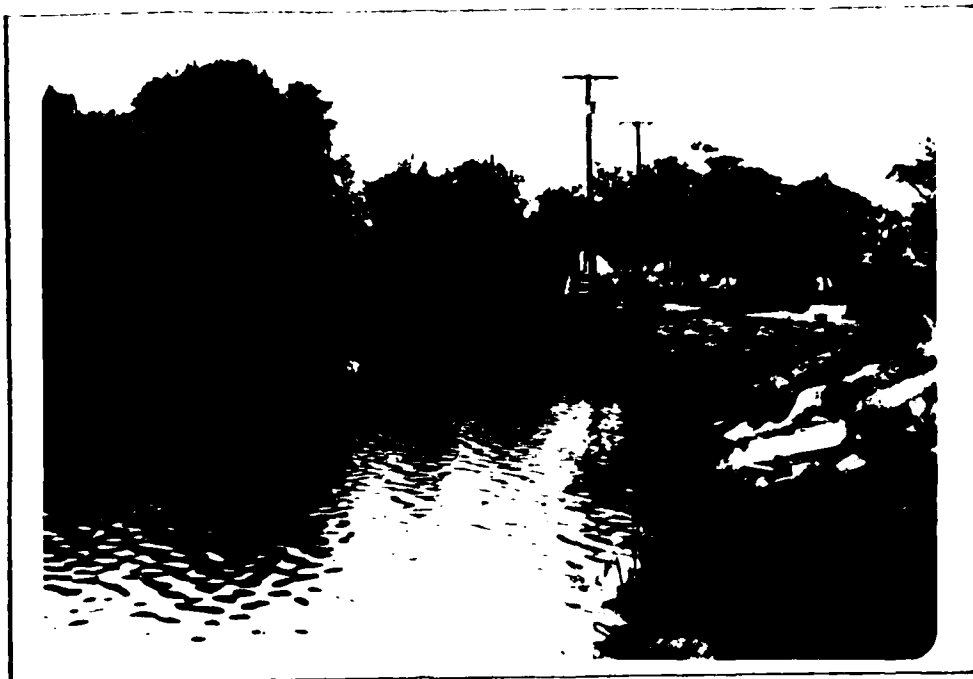
UPSTREAM OVERVIEW LOOKING TOWARDS LEFT ABUTMENT  
(8/12/80)

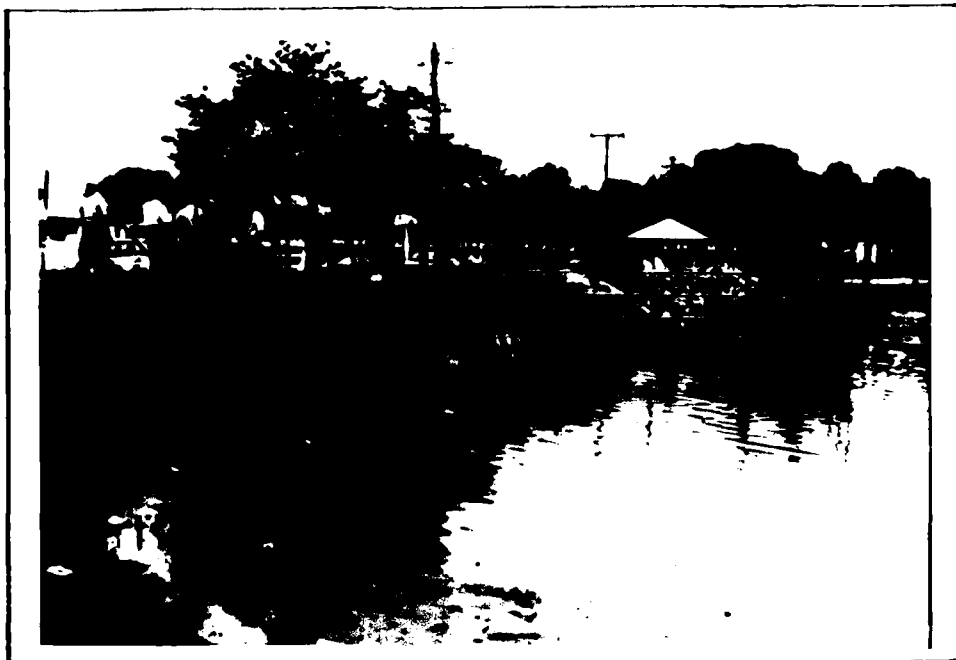
1. UPSTREAM OVERVIEW LOOKING TOWARDS RIGHT ABUTMENT.  
(8/12/80)

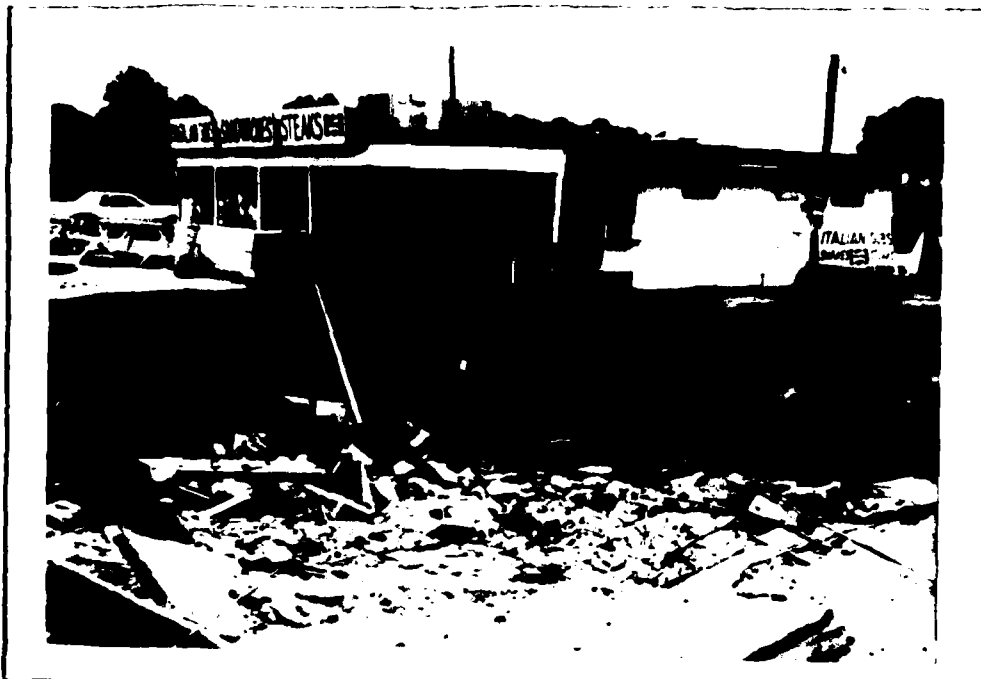
e. Downstream Channel. A large section of the east slope of the stream channel downstream of the headwall between the dam and the highway bridge has been eroded away. The cascading concrete outlet apron extending downstream of the headwall was in good condition. The concrete and brick-lined west channel slope was severely damaged but had not allowed the occurrence of significant erosion.

5. VIEW EXHIBITING UNDERMINING OF RESTAURANT DOWN-  
STREAM OF THE RIGHT ABUTMENT. AUTO IN LEFT BACKGROUND  
IS TRAVELING UPON U.S. ROUTE 13.  
(8/12/80)

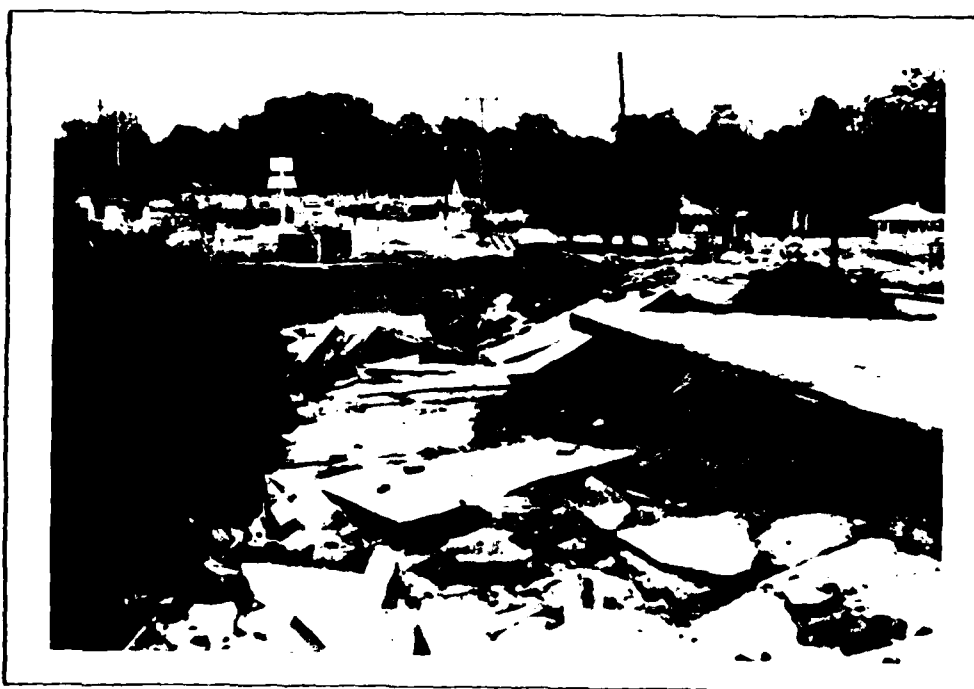
b. Dam. The overtopping which occurred on July 29, 1980, resulted in erosion of about five feet of the downstream half of the embankment. Large sections of the 40-foot wide concrete and asphalt street paving within the failure zone had collapsed and were lying on the embankment fill. The entire downstream slope had been eroded away. One section of the failure zone near the right abutment extended almost to the crest of the upstream slope and was backfilled with sandbags. A six-inch water main and ruptured four-inch diameter gas line were exposed within the dam failure zone. The upstream slope was not damaged even though it is unprotected by riprap or other slope protection. The embankment crest upstream of the street is grass covered except for a sidewalk. Two trees with trunk diameters of about six inches were growing on the dam crest. Two power utility poles have been installed in the dam crest upstream of the sidewalk. No seepage was observed flowing from the failure zone.

6. VIEW OF FAILURE ZONE LOOKING TOWARDS RIGHT ABUT-  
MENT. AREA OF OVERTOPPING EXTENDED ABOUT 500 FEET TO  
CEMETARY IN BACKGROUND.  
(8/12/80)

2. Design and supervise construction of repairs to the existing embankment section.
